SVR1200 Restores Heavily Varnished Gas Turbine!

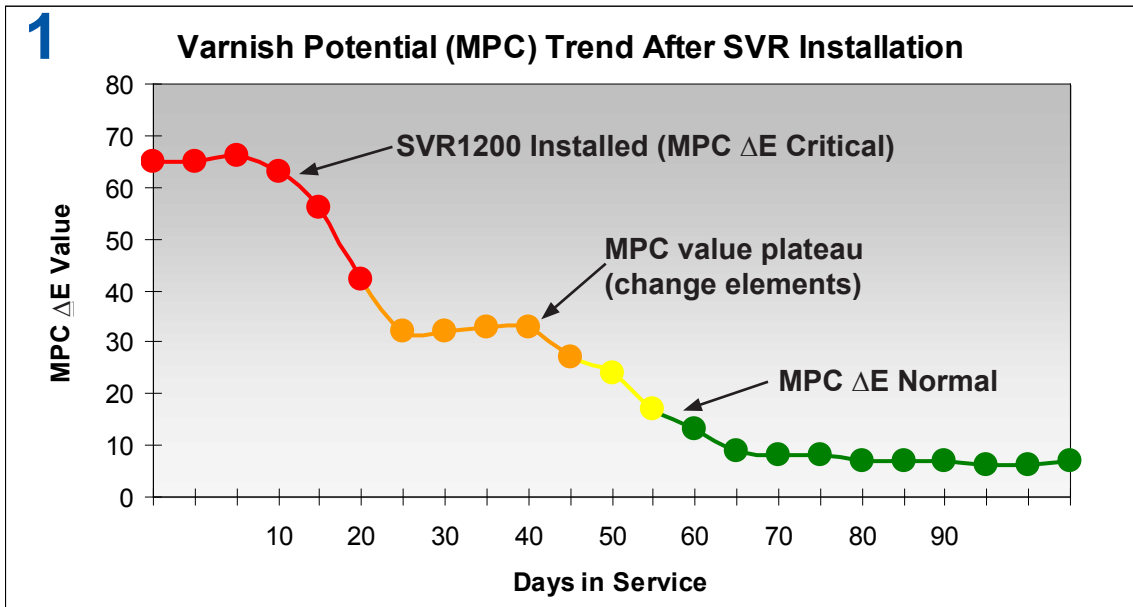
Figure 1 depicts the restoration of a heavily varnished CT where the MPC varnish potential value dropped from ~63 to ~35 in 25 days and then remained at that level indicating the need to change the SVR filter elements. Once the elements were changed the MPC drop continued and single digit MPC values were achieved. Condition monitoring via MPC or QSA is the most reliable way to know the elements are spent. A heavily varnished system might require two sets of elements to reach "Normal" condition and get into maintenance mode.
